# Two prams wrecked

on the Zuider Zee in the late eighteenth century

excavation reports 15 and 16

by Kathleen McLaughin-Neyland and Bob Neyland

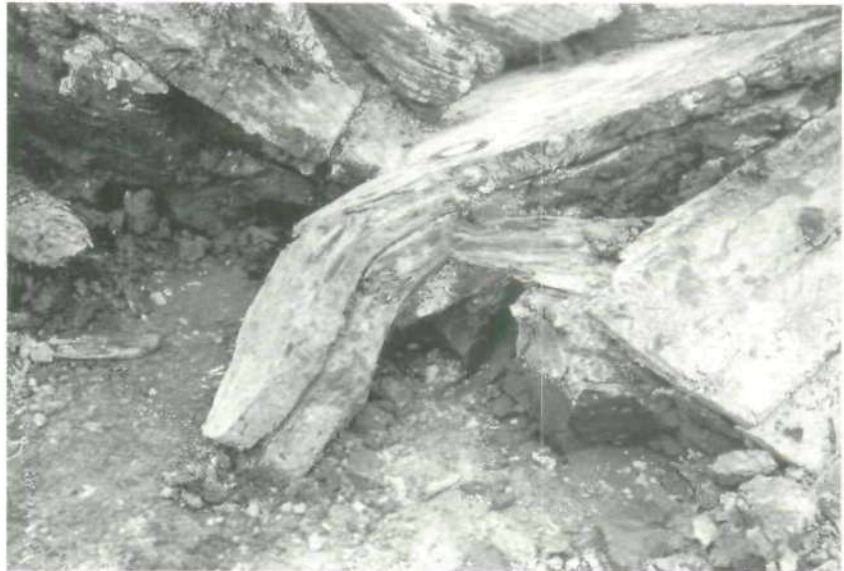
**Figure 6.**

A skeg was photographed below the tip of the central plank (figure 6), but otherwise was not measured and the length is unknown. The skeg's after end abutted the sternpost and had a shape similar to the central plank.

In the stern a skeg was present and fastened to the toe of the central plank.

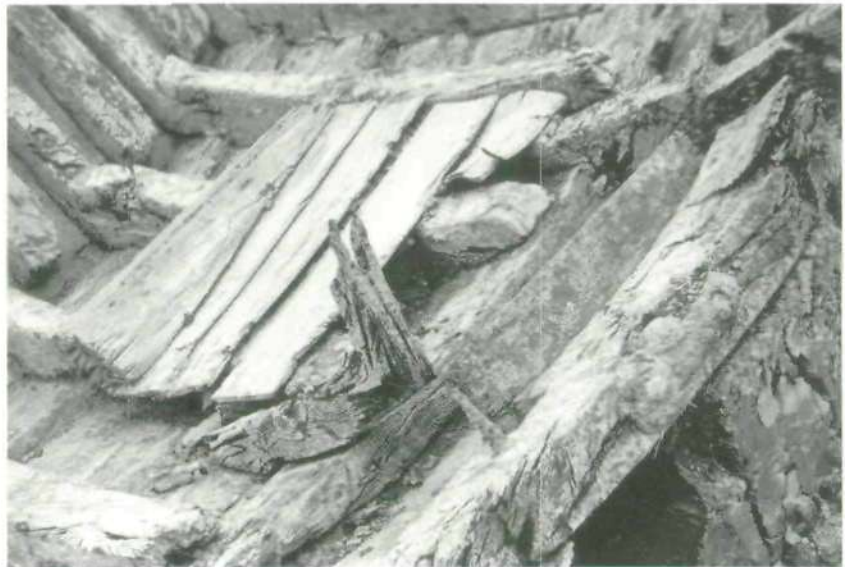
**Figure 7.**

The stern probably had a toerail like that seen in the bow. A short section of toerail was present forward of the bitt. It was notched to receive only 20 cm of the covering board. This thick, wale-like timber was rabbeted to fit over the upper edge of the sheerstrake. There was no trace of a toerail aft of the bitt, but it may have continued to the sternpost. A photograph shows a large bolt protruding inboard through this timber (figure 7).

Bolt through the toerail, ceiling planking and bitt on the port side in the stern.

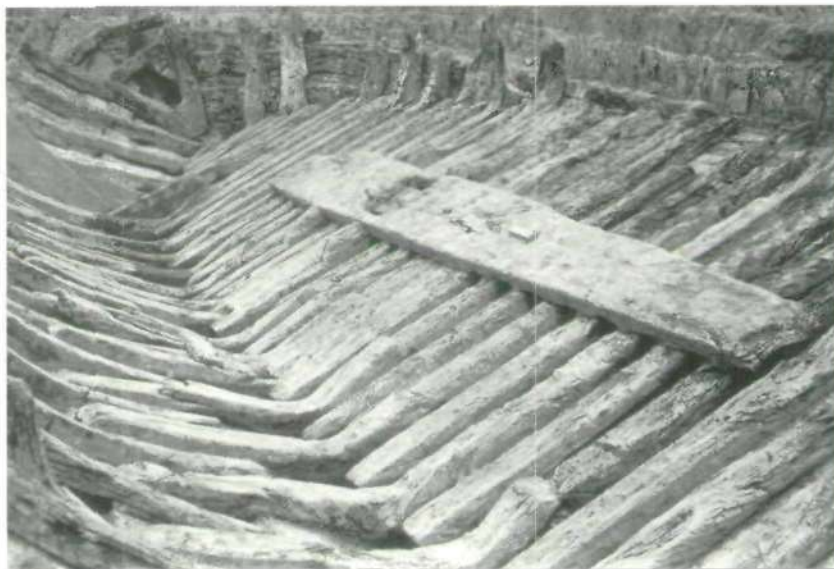
There was evidence for two bulkheads, one forward and one aft. A portion of the forward bulkhead survived on the port side and is visible in a photograph (figure 8). Fastened to the forward face of the knee at frame 62 are three boards fitted together with lap joints. The photograph shows the bottom plank edges fastened to a beam at the height of the second strake. The lower bulkhead beam appears to have been a relatively slight timber; probably, it served primarily as a lower fastening point for the boards. The bulkhead boards extended above the knee to what was probably the upper limit of the deck beam. The dimensions of the boards and lower beam can only be inferred from the photographs. The boards appear to have been thin, perhaps as slight as 2 cm, with estimated plank widths of 30 cm.

**Figure 8.**  
View forward with bulkhead and  
mast step.

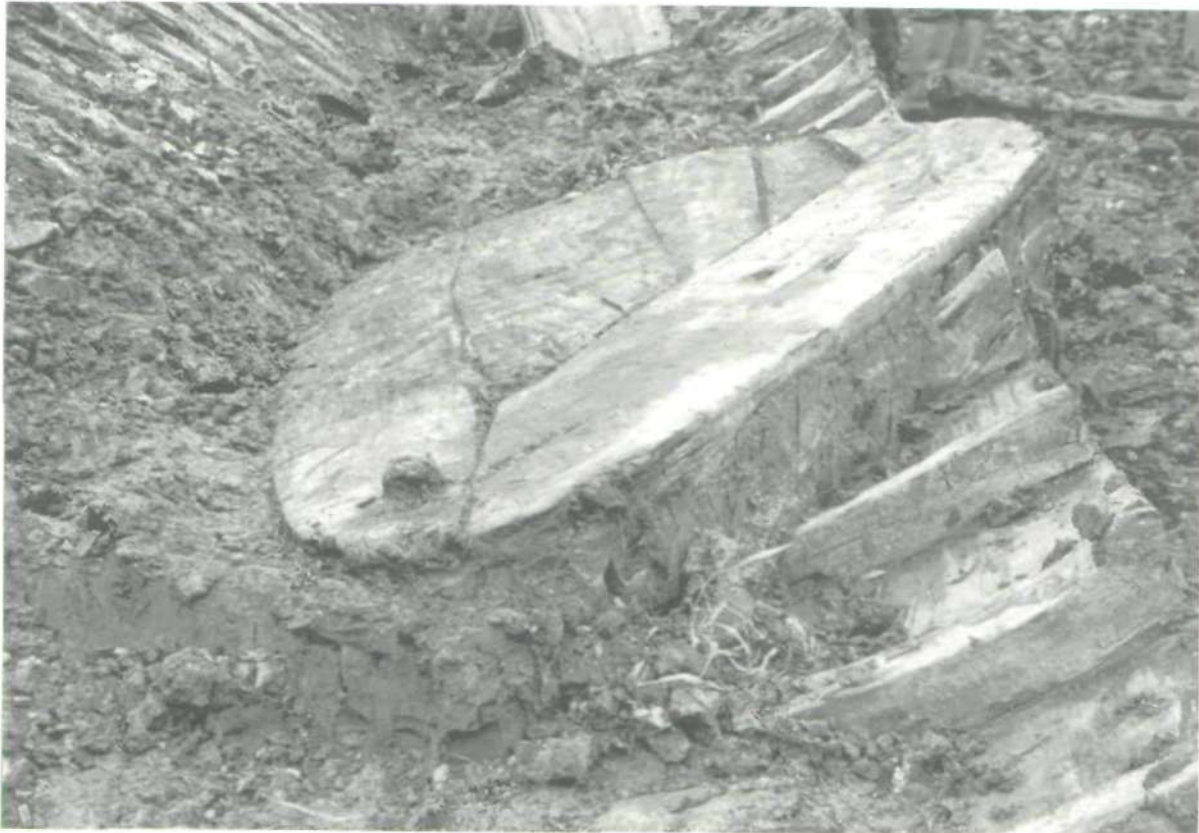
Figure 11.

A leeboard was found lying inboard on the port side (figure 11 and enclosure 2F). It has a maximum length of 3.16 m and width of 1.99 m. On the out-board face of the leeboard are five iron straps. Four of the straps fit over three pine repair planks. A curved iron strap runs along the after end of the leeboard. Also on the after end are three holes with 3 to 4 cm diameters, attachment points for a line with which to raise and lower the leeboard. Two cheek blocks were attached to the port sheerstrake for raising and lowering the leeboard, possibly, in conjunction with a fiddle-block (figure 16-99) found beyond the port side of the hull and between the forward most cheek block and leeboard bolt. One cheek block was approximately 2.82 m and the other approximately 8.27 m aft of the leeboard bolt. Thus, the fall of the leeboard tackle lead aft. This arrangement of tackle probably allowed the helmsman to raise and lower the leeboard from the vicinity of the helm.

The leeboard *in situ* on the port side of the wreck.

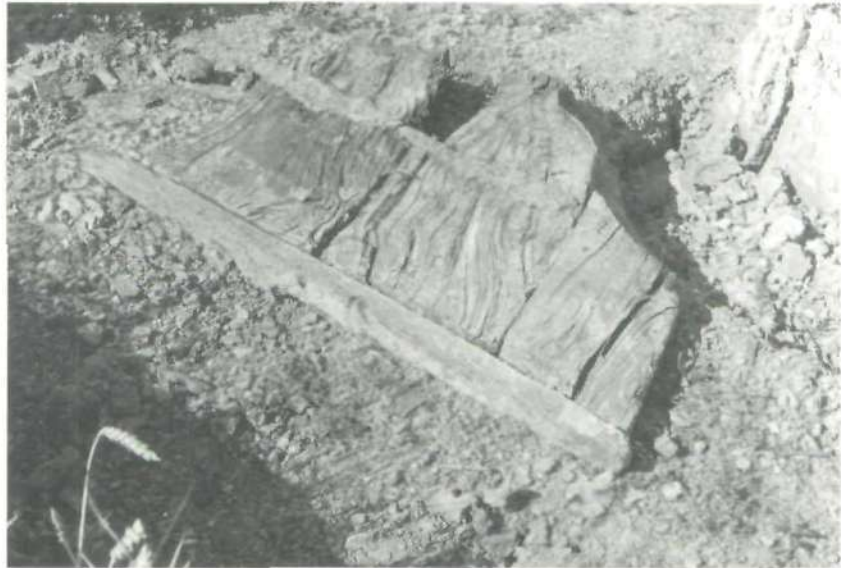
Figure 13.

The lower section of the rudder survived, but was recorded only in photographs (figure 13). It was found in a nearly upright position; the after end twisted to port so that it rested perpendicular to the hull. The surviving fragment consisted of the rudder shoe, to which were fastened three heavy planks held together by two iron straps. These iron straps were perhaps remains of the pintle straps. The upper and forward portions of the rudder did not survive.

The lower section of the E 14 rudder.

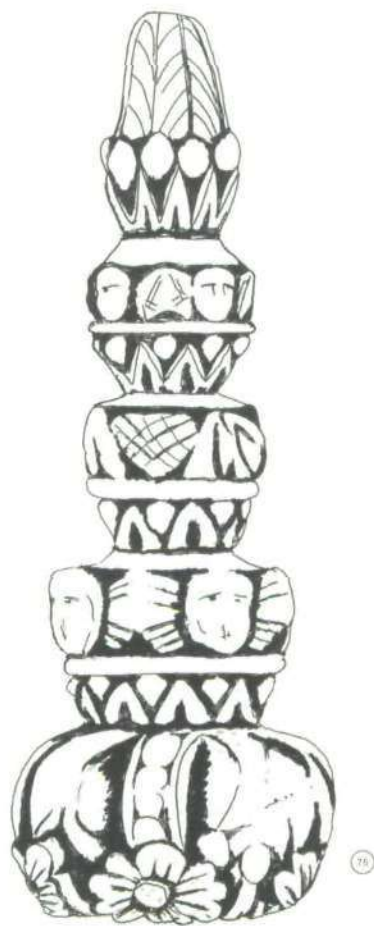
A well preserved, small decorated *mastwortel*, or mast finial (figure 18-75), was found in the bow. This kind of decorated object is uncommon in the shipwrecks of the Zuider Zee. They were used most of the time on special occasions. The length is 12 cm and it is segmented in five sections. It has a deep hole of 17 mm diameter. The lowest section is a crown with flowers. The second and fourth ones show four angelheads or sea-gods. The third section is a crown with some leaf-work, the top a crown with four feathers. This ornamentation is common for inland and so-called pleasure vessels (Crone 1926, 296 and plate 64; Huitema 1962, 199-200).

Figure 18.  
Flag pole or mast finial (*mastwortel*).

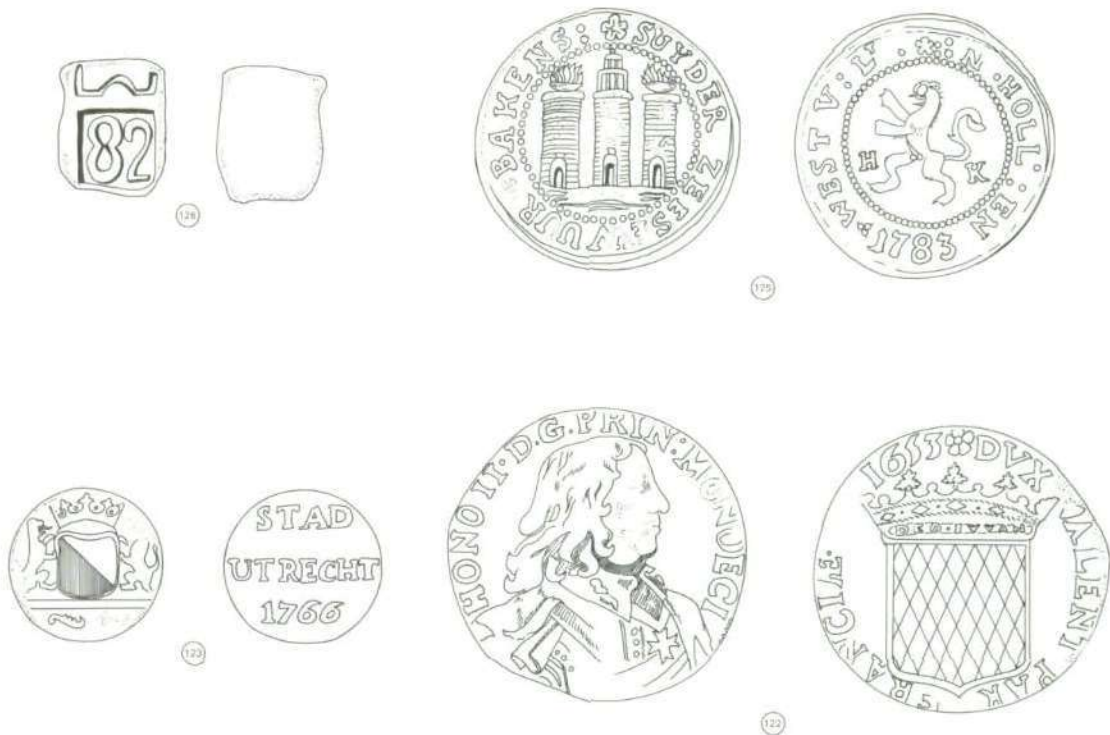
The most important artefact used in dating the ship is a lead token for the lighthouses in the region of North Holland and West Friesland (figure 20-125). These tokens were purchased annually by ships' captains to support and maintain the operation of lighthouses (*Rijksdienst voor de IJsselmeerpolders* 1987:38). The date on the token is 1783 and gives us a *terminus post quem* for the wreck. Also found was a small lead object resembling a baling seal (figure 20-126). Impressed upon one surface of this seal is a cipher mark of "82". K. Vlierman (1990:4) suggests that this seal may be an example of a lighthouse token, albeit from a different lighthouse, and the cipher "82" indicates the year 1782.

Figure 20.  
Coins and tokens.

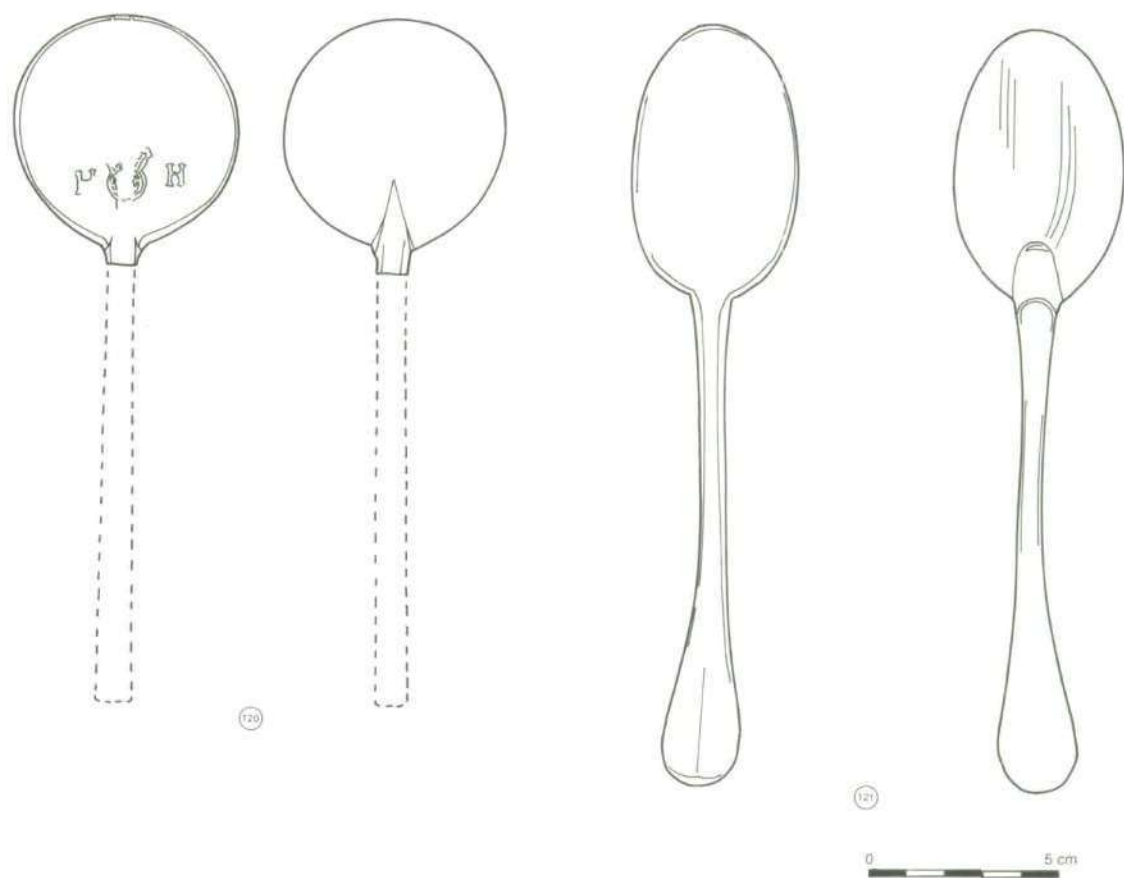
Figure 25.  
Two pewter spoons.

Similar examples for both types of spoons were recovered from the excavation of the *Amsterdam*, an East-India merchantship that sank in 1749 (Marsden 1985:139).

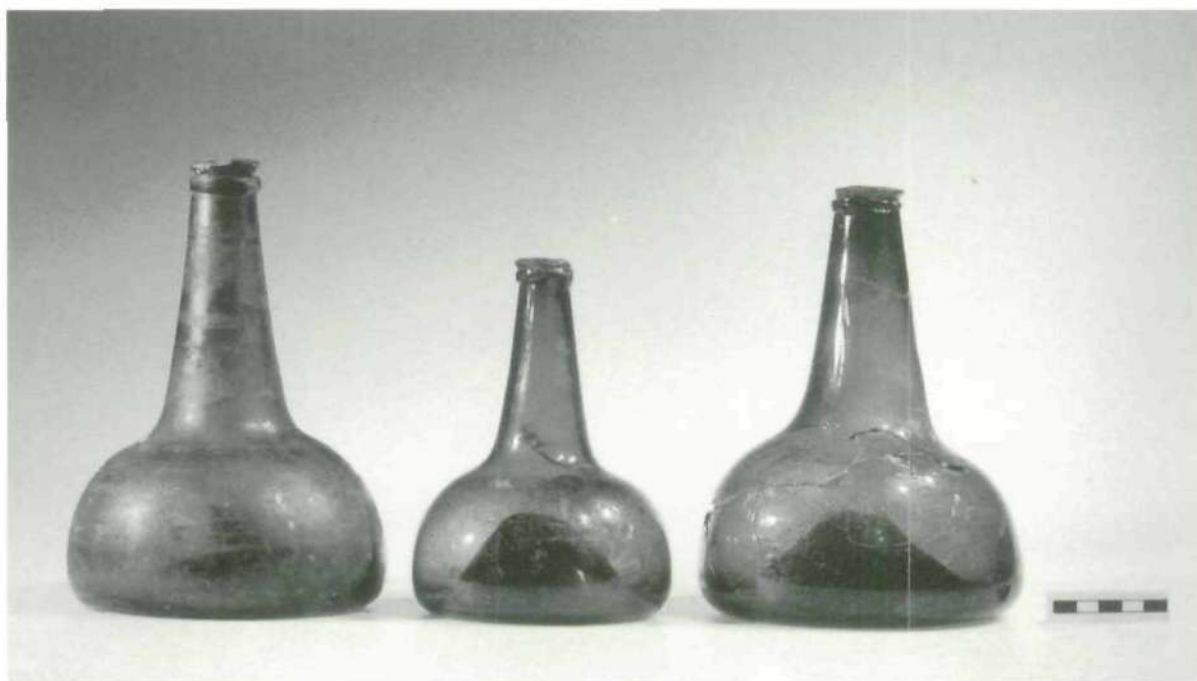
Figure 26.  
"Tigerware" jar and wine bottles.

Three intact onion bottles were recovered (figure 26, 27-31, 27-32 and 27-33). They range in size from 16-20 cm high and all have a string finish. Shards from at least one more wine bottle and perhaps a case bottle comprise the remainder of this category.

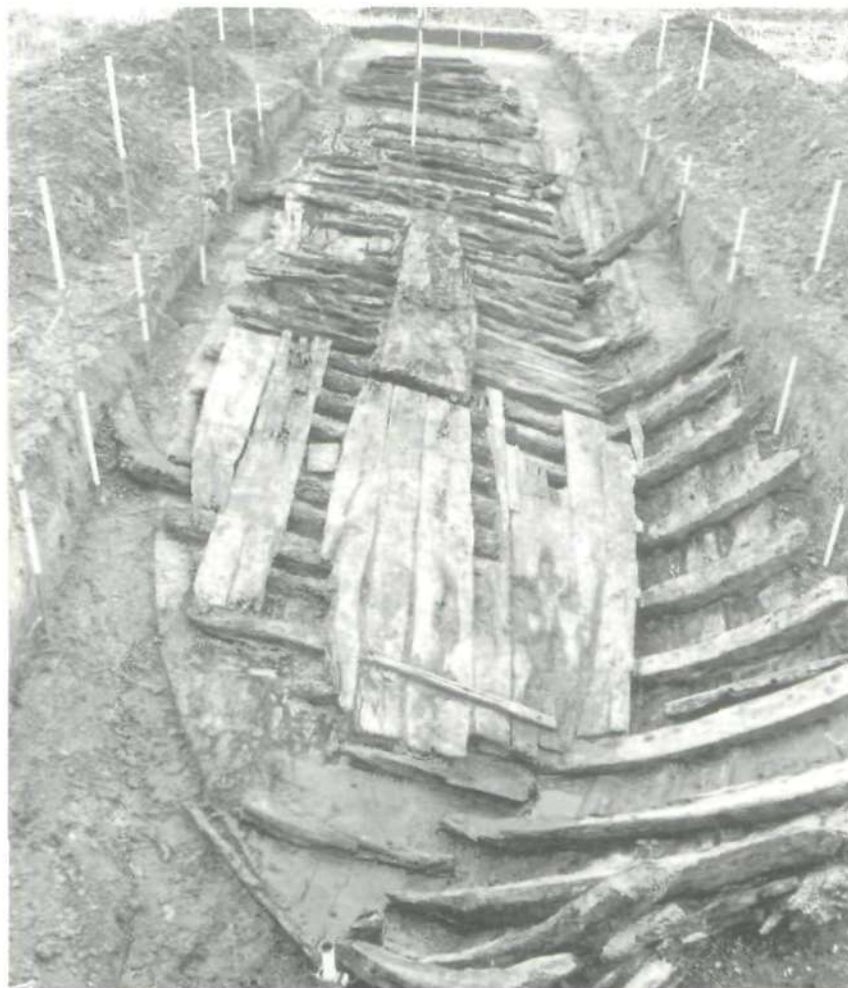
**Figure 30.**  
The hull with frames, mast step and ceiling planking.

The excavation began on August 4, 1980 and continued until August 23. The wreck was shallow, covered by only 20 to 25 cm of overburden (figure 30). Stereophotographs were not taken because of difficulty in locating fixed and recognizable points. Recording was performed, as on the E 14, with steel tapes, water levels, and plummet. A detailed site plan of the wreck was drawn at 1:20 scale. The field drawings consist of a view from above, a longitudinal section, nine transverse sections (enclosure 4B and 4C), and a provisional reconstruction of the port-side planks with the stem attached. A separate plan shows the position of artefacts and loose fragments associated with the wreck (enclosure 4A).

Remnants of ceiling planking were present in the bow (figure 30). The ceiling did not survive elsewhere in the vessel, but its presence throughout was suggested by iron nails on the upper surface of floor timbers both amidships and in the stern. The eight ceiling planks on the floor timbers were 2-3 cm in thickness with widths from 20-40 cm. Two short and narrow boards were fastened on top of these ceiling planks.

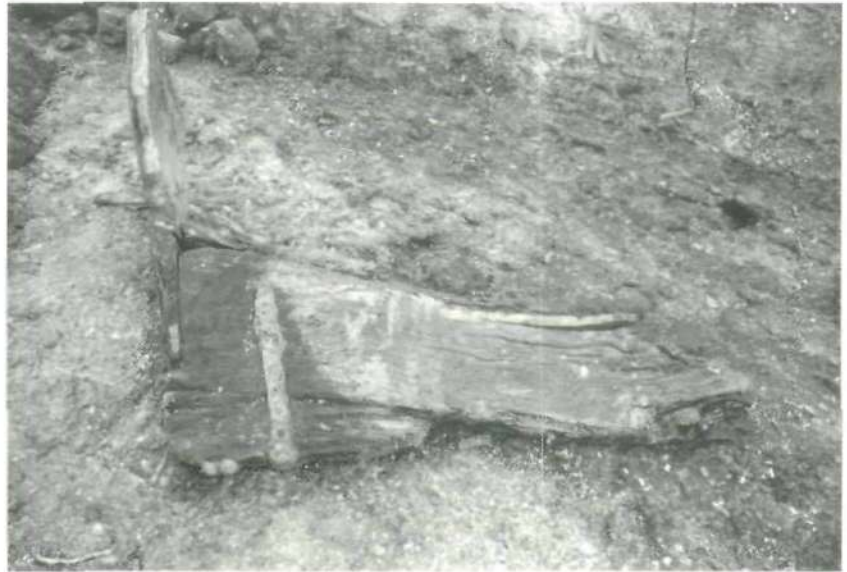
Figure 33.  
Stem and part of the central plank.

A fragment of the stem survived to a height of 1.34 m. Still fastened in their rabbets were port and starboard stealers, and port second and third strakes. The stem heel was 50 cm moulded and 20 cm sided inboard, but narrowed outboard to a minimum of 16 cm (enclosure 5A and figure 33). The stem was fastened to the bottom by three treenails. The rabbet was 3-4 cm wide. A breasthook was nailed to the stem at the lower edge of the third strake with a single iron nail.

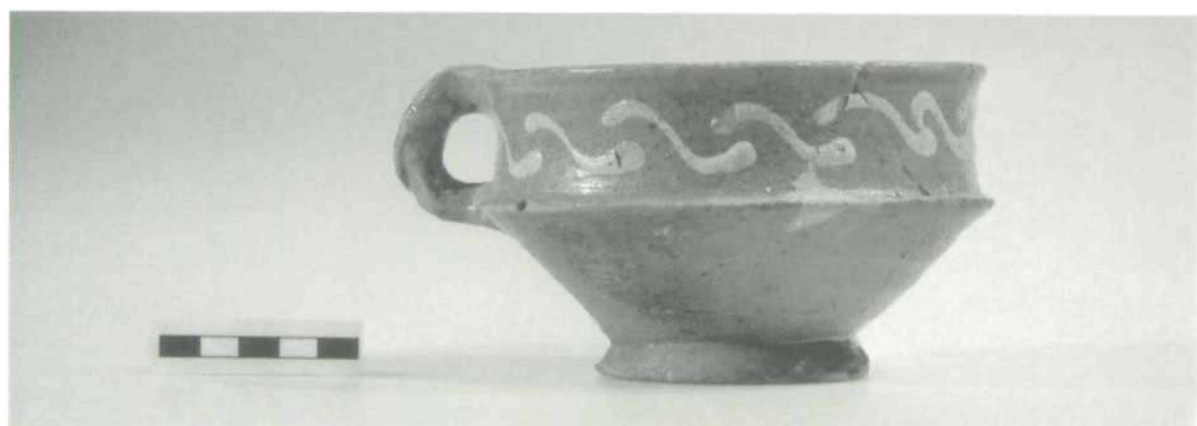
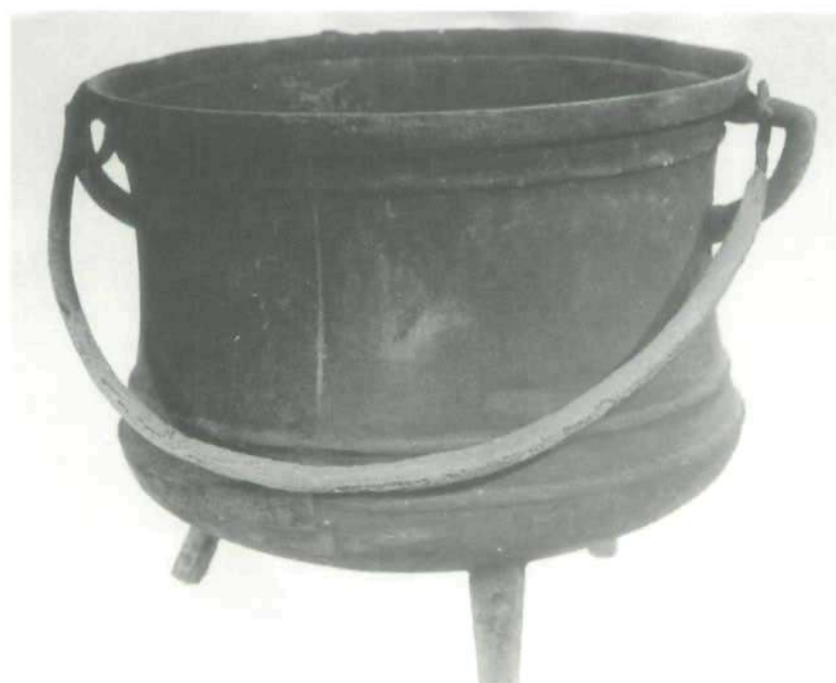
**Figure 37.**  
Dish, bowl and iron cooking pot.

Two iron cooking containers were found. The cast iron cooking pot has a bale handle, three legs, and a rim diameter of 23.5 cm (figure 37 and 38-75). One leg is not original, but was replaced by a bolt and washer. Very little remains of the iron pancake pan (figure 38-77). Enough remains to obtain an estimated diameter of 23 cm and to note that the bottom of the pan had been repaired, as evidenced by the small nail or brad holes in it. One batter bowl was presumably used for the preparation of pancake batter, pancakes being a common staple in the crew's diet (figure 37 and 38-11). Two ceramic bowls have fire blackened exteriors indicating their use as cooking vessels. One is a red-earthenware bowl (figure 37, 38-5 and 38-6) with a spout and a handle. It is rather small having a rim diameter of only 13.5 cm. The bottom is missing, but the rest of the exterior shows evidence of heating. The second bowl (14) is fragmentary with an estimated base diameter of 10 cm. It has a white paste with a slip design in brown and green and has an interior and exterior lead glaze. The underside is fire-blackened. The last item from this category is a small copper lid to a tea kettle (39), of which comparable examples exist in the Museum collection. It is 11.6 cm in diameter and bent. There is a hole in the center where the handle should be. It was recovered aft next to the iron cooking pot, but the kettle was not found.

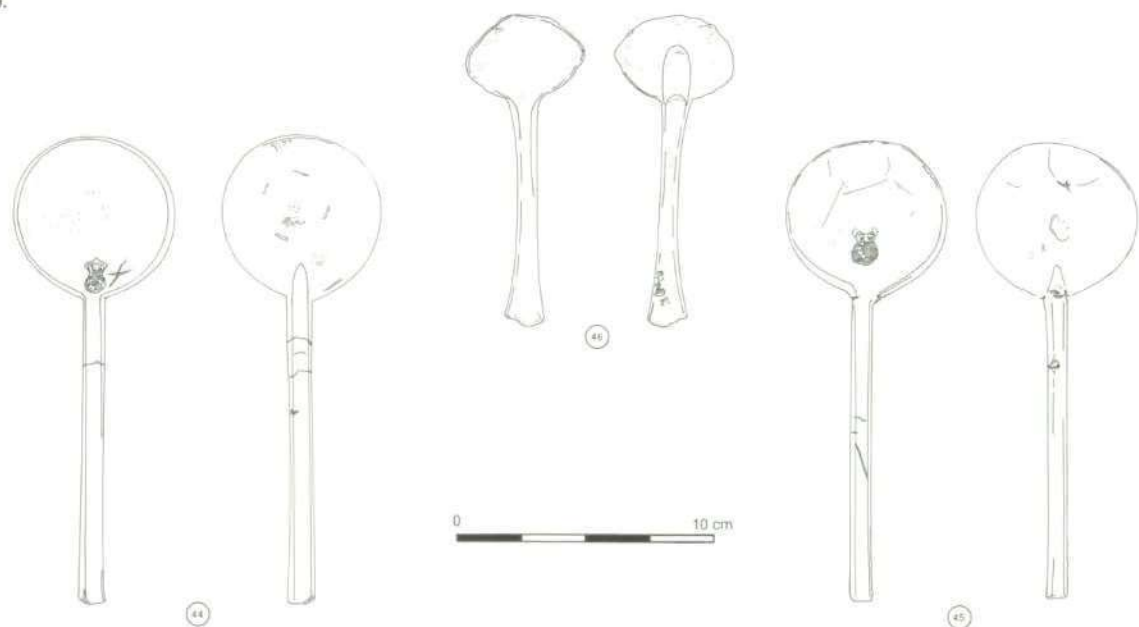
Figure 40.  
Spoons.

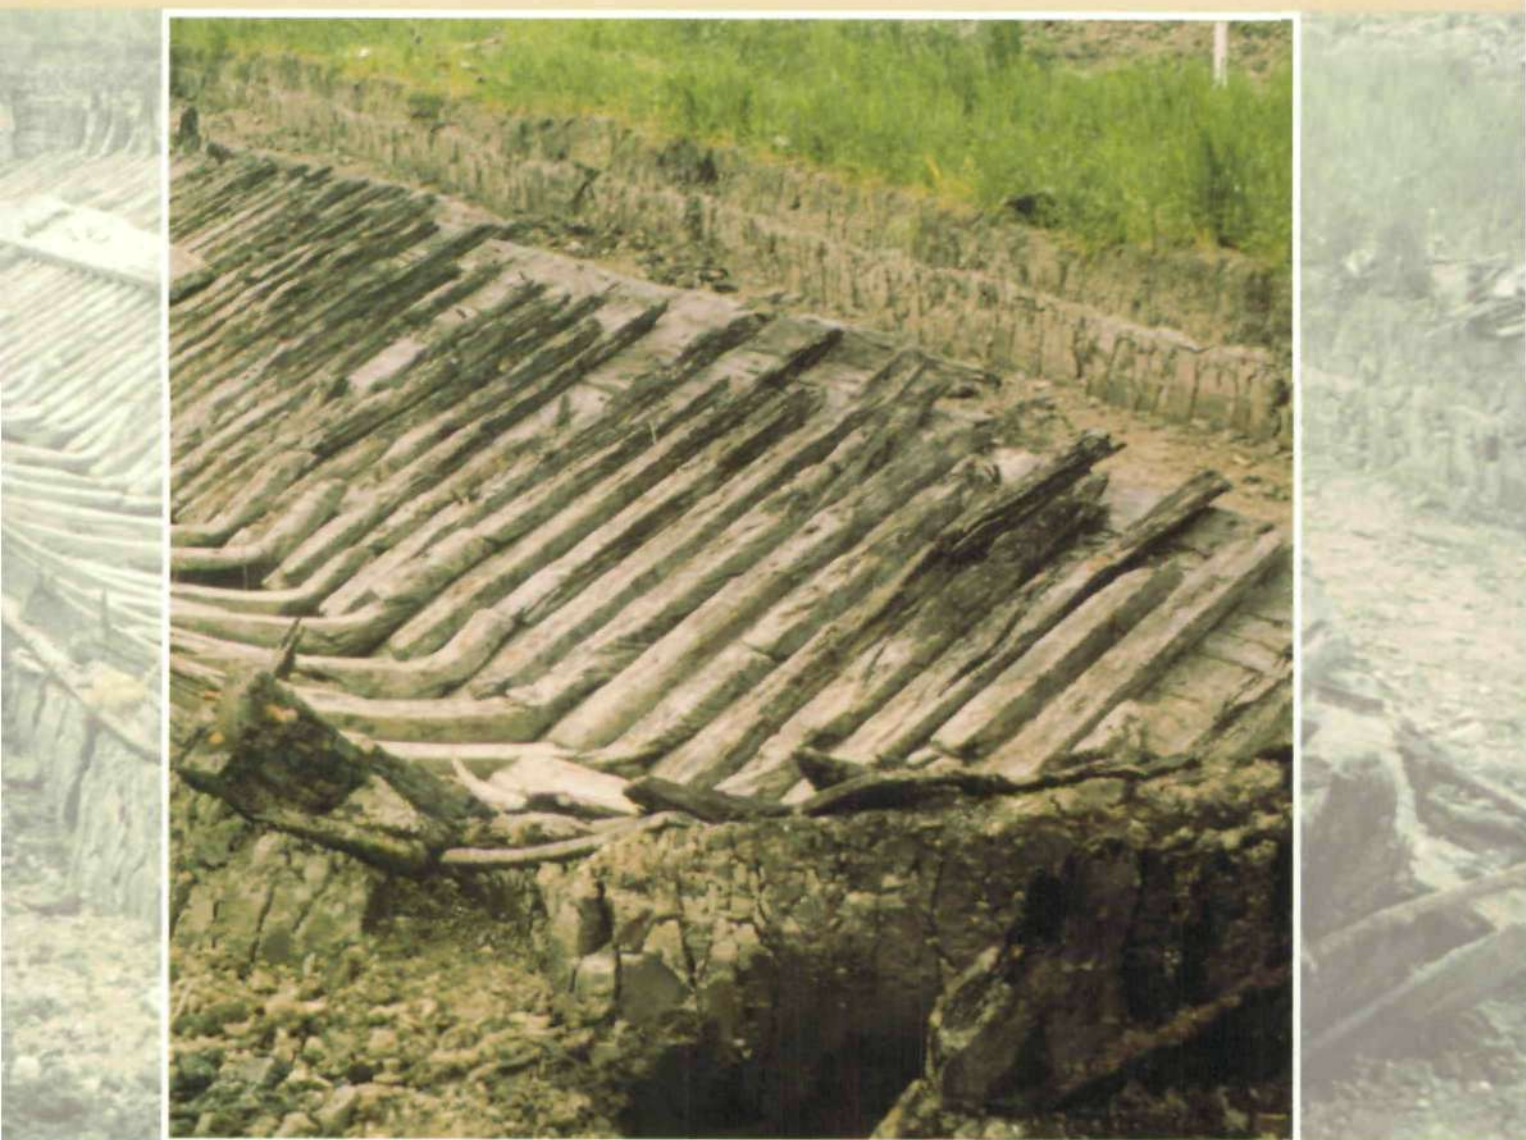
A. Strake Diagram  
scale 1 : 50

Two prams of the eighteenth century  
Excavation on lot E 14 in Oostelijk Flevoland  
Enclosure 3 A. Strake diagram  
(drawn to the inside corners of the landing)  
B. Cross sections and strakes  
C. Main frame

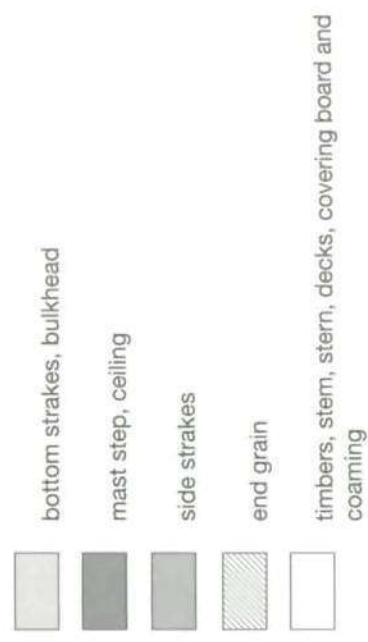
**A. Longitudinal section**  
scale 1 : 50

Two prams of the eighteenth century  
Excavation on lot E 14 in Oostelijk Flevoland  
Enclosure 2 reconstruction
